## BELLEVUE HILL IMPROVEMENT ASSOCIATION

### Re: 7 Vershire Street, West Roxbury - Request for Coordinated Safety and Compliance Review

## Visual Documentation - 7 Vershire Street

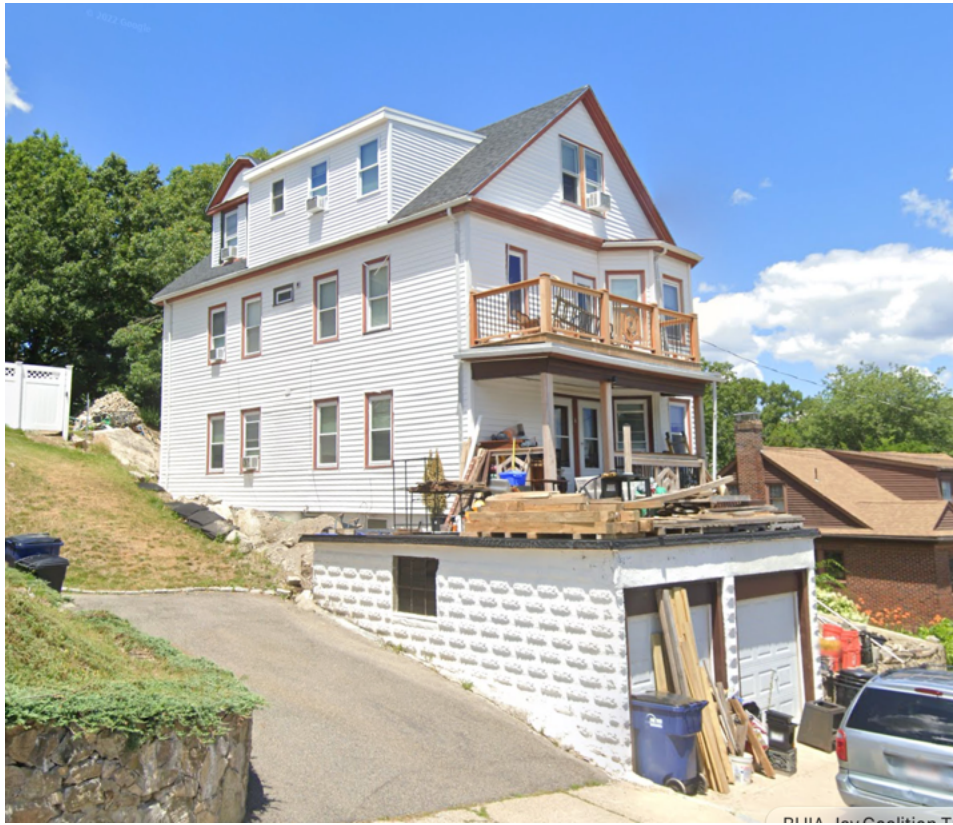
Google Street View - June 2022. Side/rear view of 7 Vershire Street showing exposed/disturbed ground and rock along portions of the building perimeter.

- whether any inspection includes evaluation of conditions along the property boundaries adjoining the affected properties, including excavation, lateral soil support, retaining walls, grading and drainage, and whether additional evaluation by a structural, geotechnical or other appropriate professional is warranted;

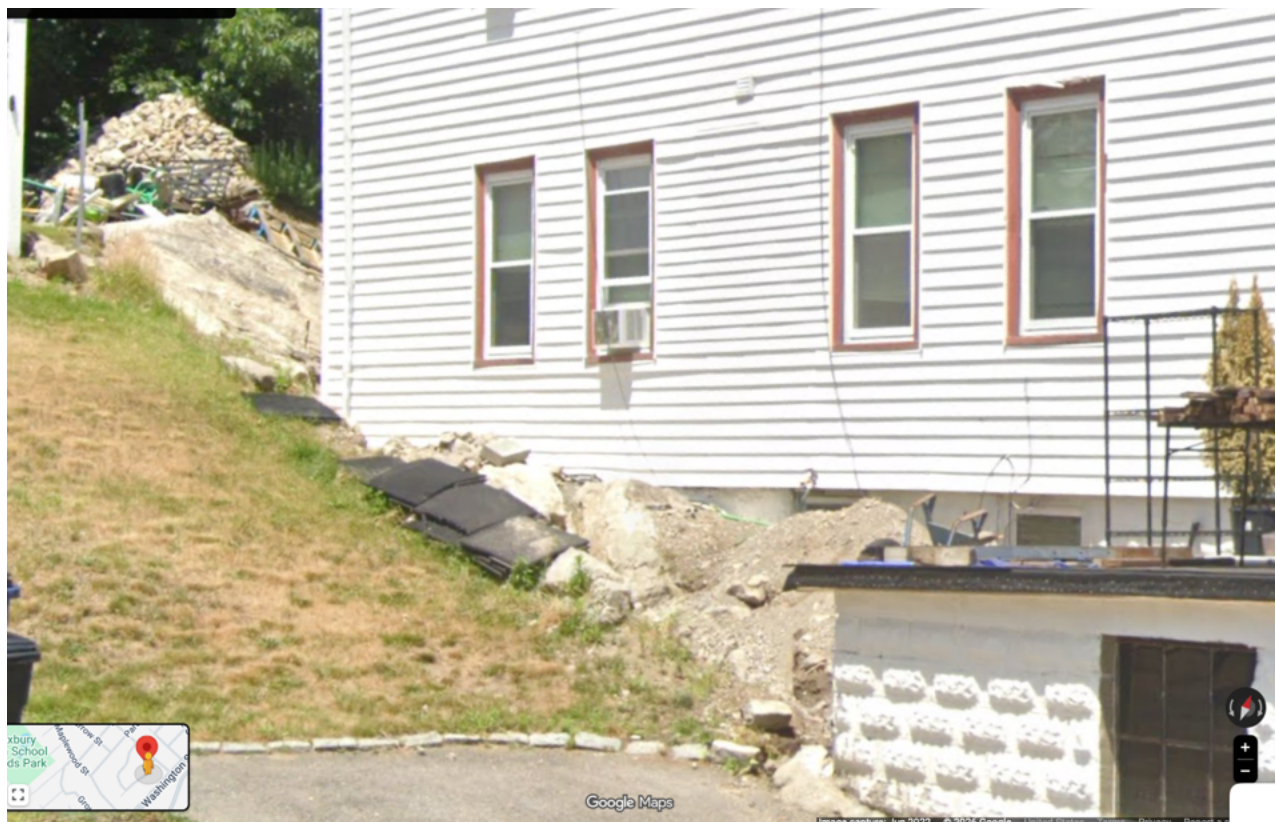
Google Street View - June 2022. Closer side view of 7 Vershire Street showing exposed/disturbed ground and rock in close proximity to the building perimeter.

- whether ISD has evaluated effects on the foundation, the safety of people living in the building, adjoining retaining walls and properties, soil stability, drainage and water conditions;
